**Field Change Order Number: 00-AS800 F001**  
**Field Change Order Name: ASR800 Combo Slot –12v issue**  
**Customer Document Number: EK-COR64-CL**

Subject: AlphaServer 800 64-bit PCI slot restrictions

Document number: EK-COR64-CL A01

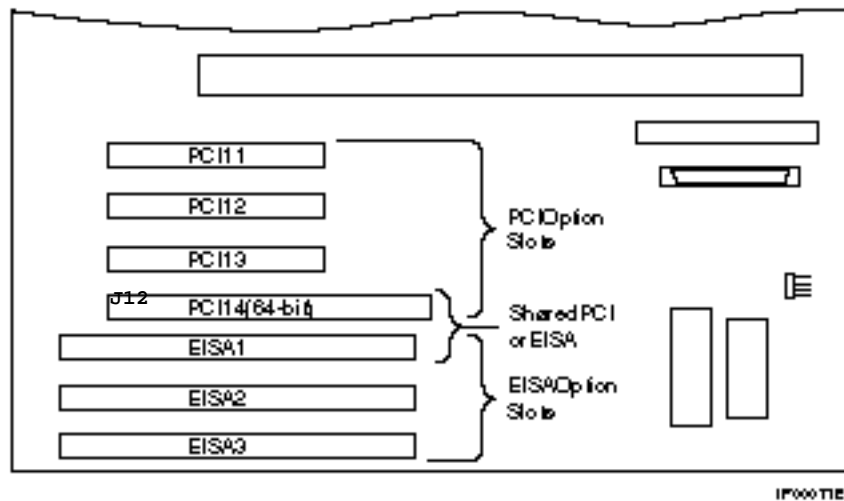
**Figure 2**

Digital has determined that a condition exists in the AlphaServer 800 system module which affects the 64-bit PCI option slot #14 (J12) that may cause electrical damage to some 32-bit and 64-bit PCI option modules, or other devices that are installed into that slot. The 64-bit PCI connector pin that should be providing the option module with -12 volts is actually supplying +12 volts. Only options that require -12 volts are susceptible to damage in this slot and most options do not use this connector pin. To date, Digital has not received any reports of such damage. This condition does not pose a product safety hazard, and all other PCI and EISA option slots in the AlphaServer 800 are unaffected.

We suggest that as a precautionary measure, customers apply a piece of non-conductive tape across the top of the 64-bit PCI slot to inhibit installation of option modules. The affected 64-bit PCI slot can be identified by the legend “J12” marked adjacent to the 64-bit PCI connector on either variation of the system module. See Figure 2 below.
